Proposed Chassell to Houghton Recommended management plan

This plan covers the former Duluth South Shore and Atlantic railroad grade from the US 41 crossing south of Chassell to the Portage Lift Bridge in Houghton, a distance of 9.36 miles. The Department of Natural Resources owns the south eight mile segment. Michigan Technological University owns within its boundaries. Michigan Department of Transportation owns the north segment. The grade began as the Marquette Houghton and Ontonagon Railroad (?), a land grant railroad. The tracks were removed in 199_ and DNR gained ownership in 2003. DNR acquired the grade from SBC Ameritech in a UP wide purchase of railroad grades. SBC maintains an interest in the grade due to its buried fiber optic communications line. Protection of this fiber optic line is extremely important.

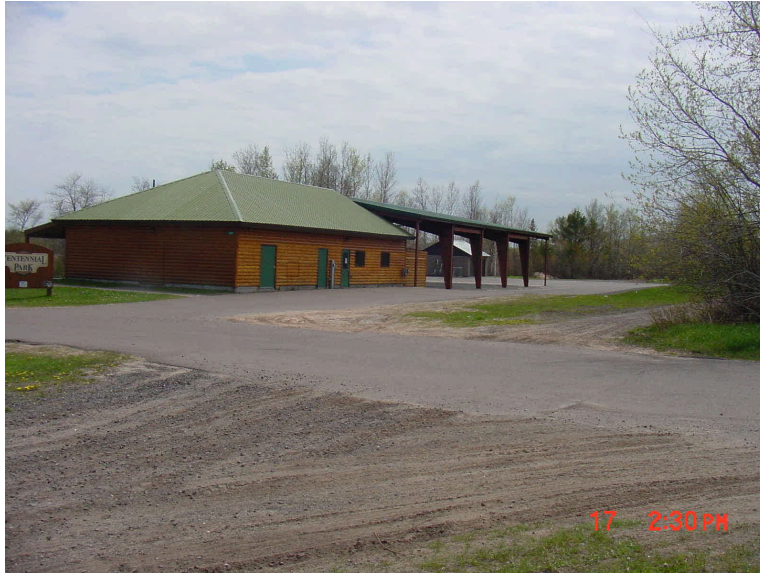
Chassell park south of Third street crossing

The recommended trail head is at the Third Street crossing in the Village of Chassell. Chassell maintains a park, boat launch, parking and toilets at this site. This site has good access and is close to one end of the grade.

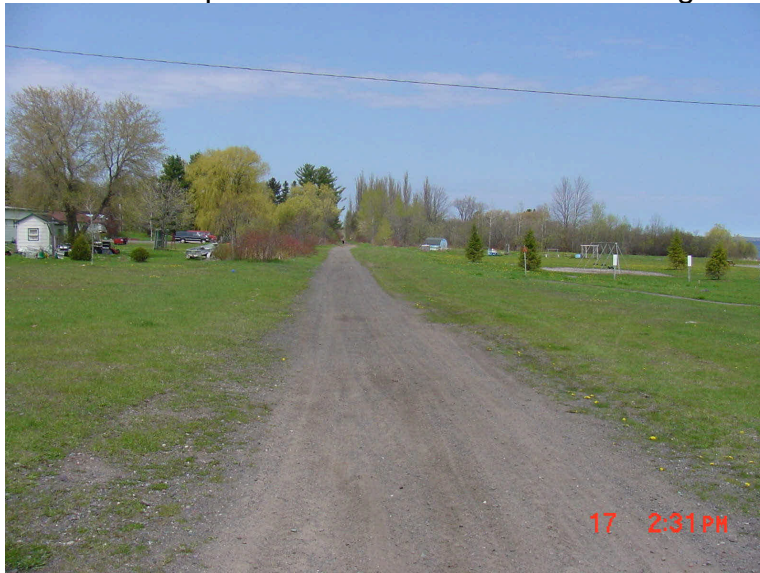
Looking north from third street at Chassell park

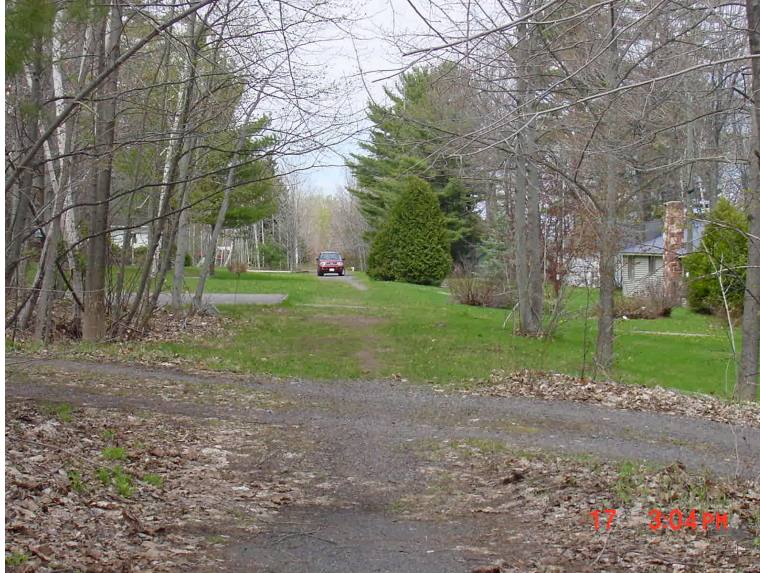
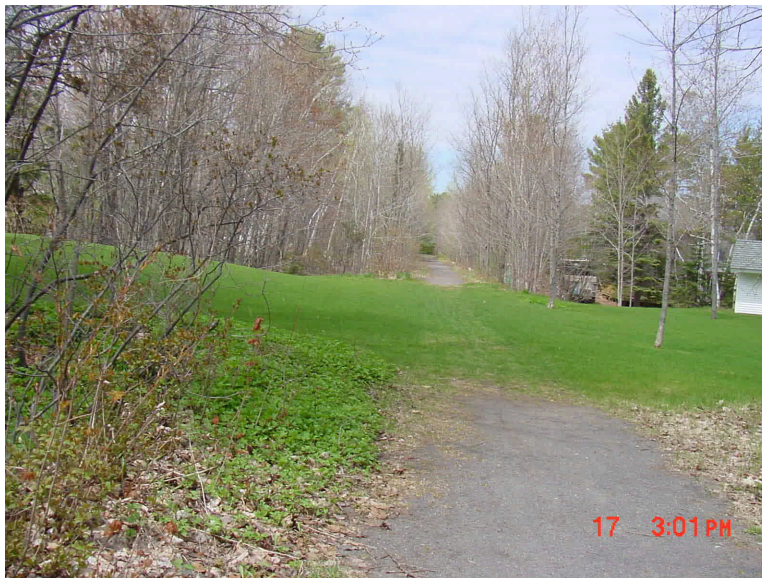
The committee recommended that the surface not be paved. The part of the grade north of the Pilgrim River Bridge is already paved. The intent was to keep the remainder as an unpaved trail. There are some issues here that will have to be tracked. Much of the trail in this segment is adequate as is. There are places where we will have to upgrade the surface (wet spots, or lawns) to gravel.

Several road crossings will need some gravel approach work. An alternative material of blacktop salvaged from road jobs (applied as gravel) may be worth considering. DNR should review the surface issue after five years of use to determine if the unpaved surface is adequate.

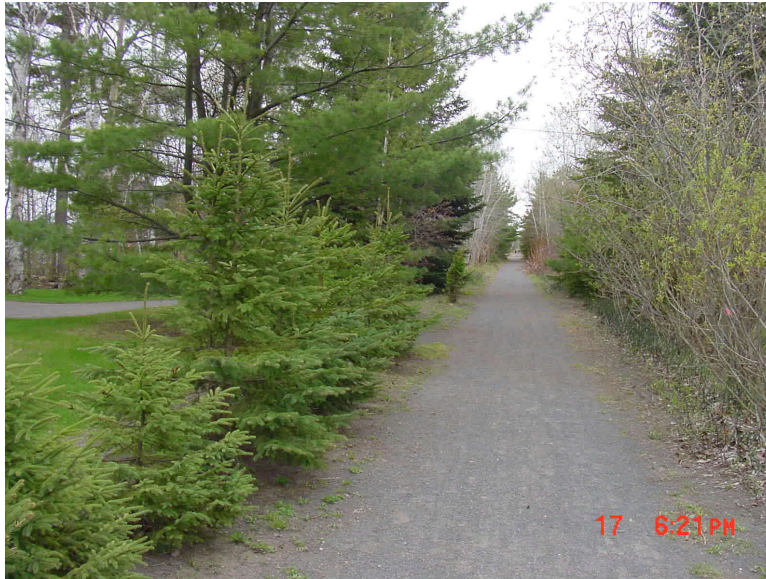
conifers planted too close to the trail

The trail needs to be brushed wide enough for the projected use, and for the maintenance equipment (snowmobile groomers). This means that branches will have to be trimmed. The goal is to have a 12 ft wide by 12 ft high clear area. Where possible, trees adjacent to the trail surface will be retained for shade. Anticipated problems: Several adjacent landowners have planted spruce trees immediately adjacent to the trail surface. It appears that these will have to either be cut or moved. The preferred option is to move them with a tree spade.

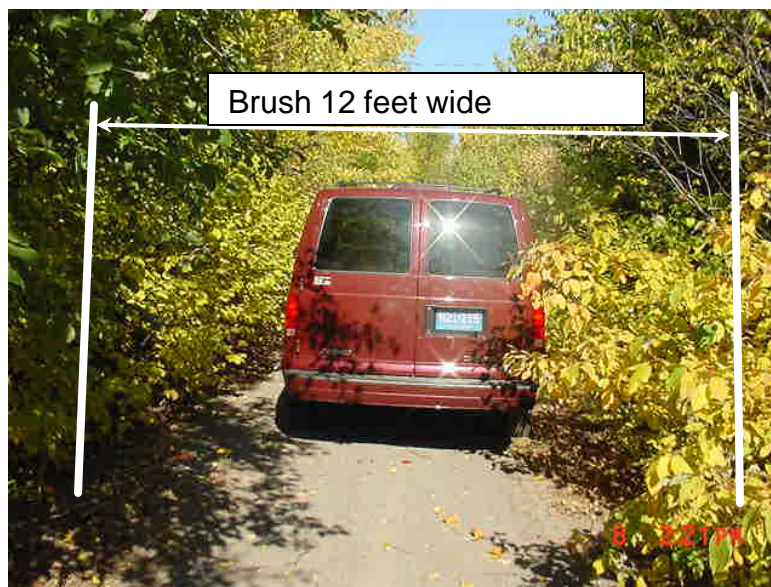
Branches too near trail.
